HERBICIDE ORANGE SITE CHARACTERIZATION STUDY EGLIN AFB

FINAL REPORT
APRIL 1984 - SEPTEMBER 1986

This report describes the procedures, results, and analysis of a soil sampling program performed at, and in the immediate vicinity of, the Hardstand 7 area of EAFB. In accordance with a previously approved sampling protocol, 276 samples of soil and concrete were collected from the hardstand area, which is about 130 feet in diameter, and includes a 10-foot-deep concrete pit also contaminated by HQ handling. In addition to the soil and concrete samples, over 75 laboratory analyses were performed and reported for a variety of quality assurance criteria.

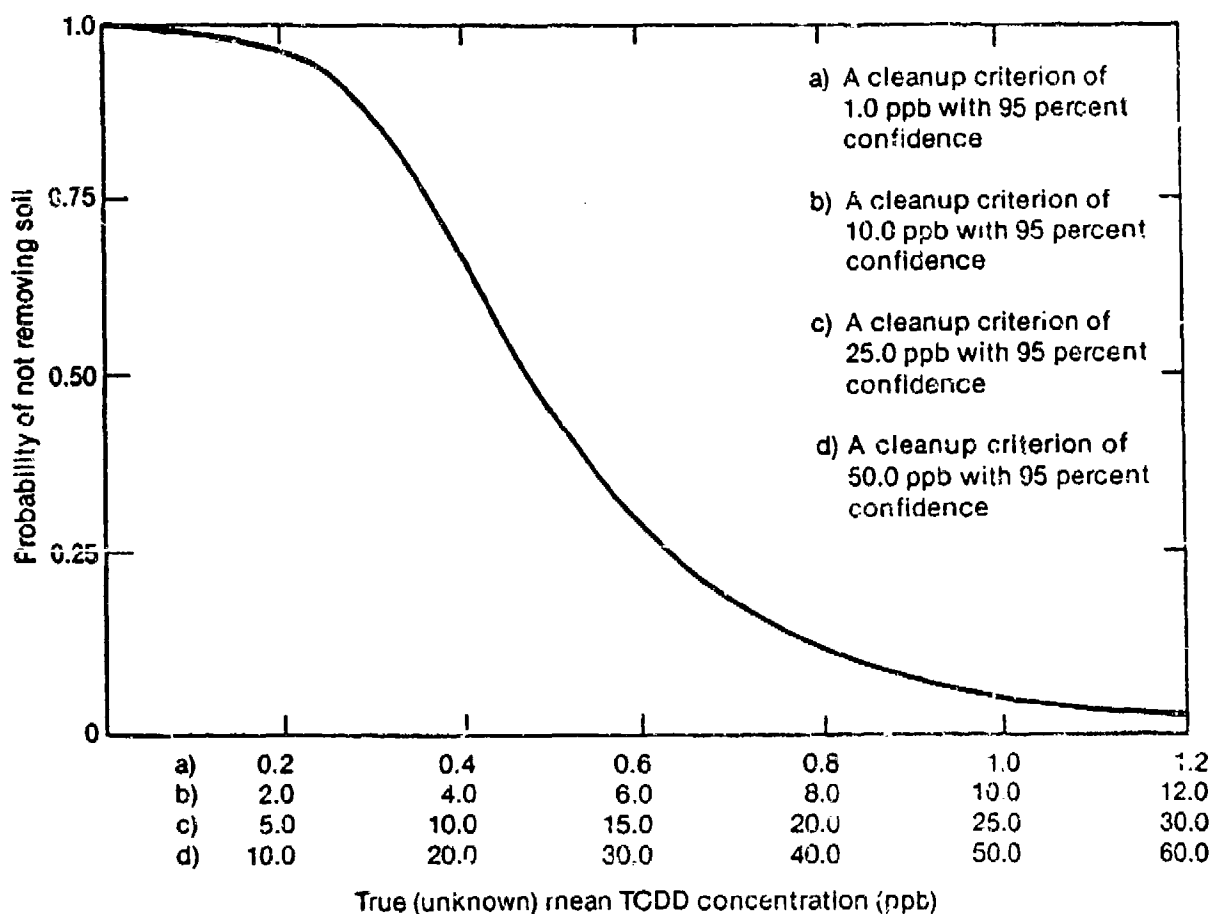
Figure 30. Probability of Not Removing Soil from the Plot with Cleanup Criteria of 1.0, 10.0, 25.0, and 50.0 ppb with 95 Percent Confidence.

Using the two plots from the hardstand area, an estimate of the within-plot variance was obtained. The sample results were transformed using the natural logarithm. The Shapiro-Wilk W test (Reference 7) for normality indicated that the composite samples within the replicated plots are better fit by a log normal than a normal distribution. It is necessary to assume that the within-plot variation is consistent from plot to plot because of the lack of replicate samples within each plot. The estimate of the pooled variance (a weighted average of the individual variances from each replicated plot) combines both sampling and analytical variability, and this estimate was used to calculate upper confidence limits on the surface samples. These limits are presented in Table 15 for 65, 80, 90, and 95 percent confidence levels. For the replicated plots, the upper confidence limit is a limit on the geometric mean of the composite samples. In plots with a single sample, it is a limit on the single composite result. When computing upper confidence limits, less-than-detectable results were replaced by the reporting limit. Figures 22 through 29 display the plots with upper 65 and 95 percent confidence limits exceeding cleanup criteria of 1.0 ppb, 10.0 ppb, 25.0 ppb, and 50.0 ppb. Figure 30 presents the probability of not cleaning up a plot for a range of values of the true mean TCDD concentration. The probabilities are plotted for the cleanup criteria of 1.0 ppb, 10.0 ppb, 25.0 ppb, and 50.0 ppb with 95 percent confidence.

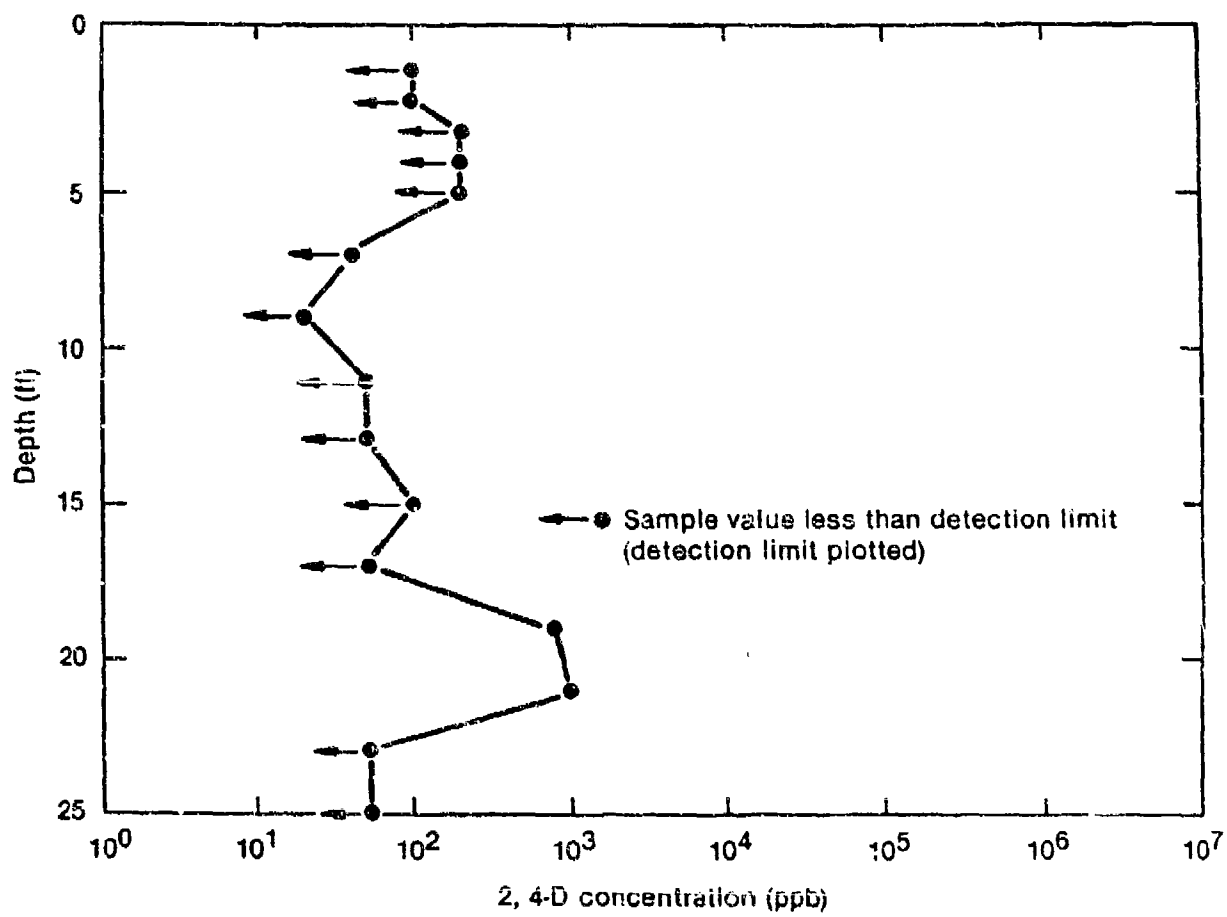
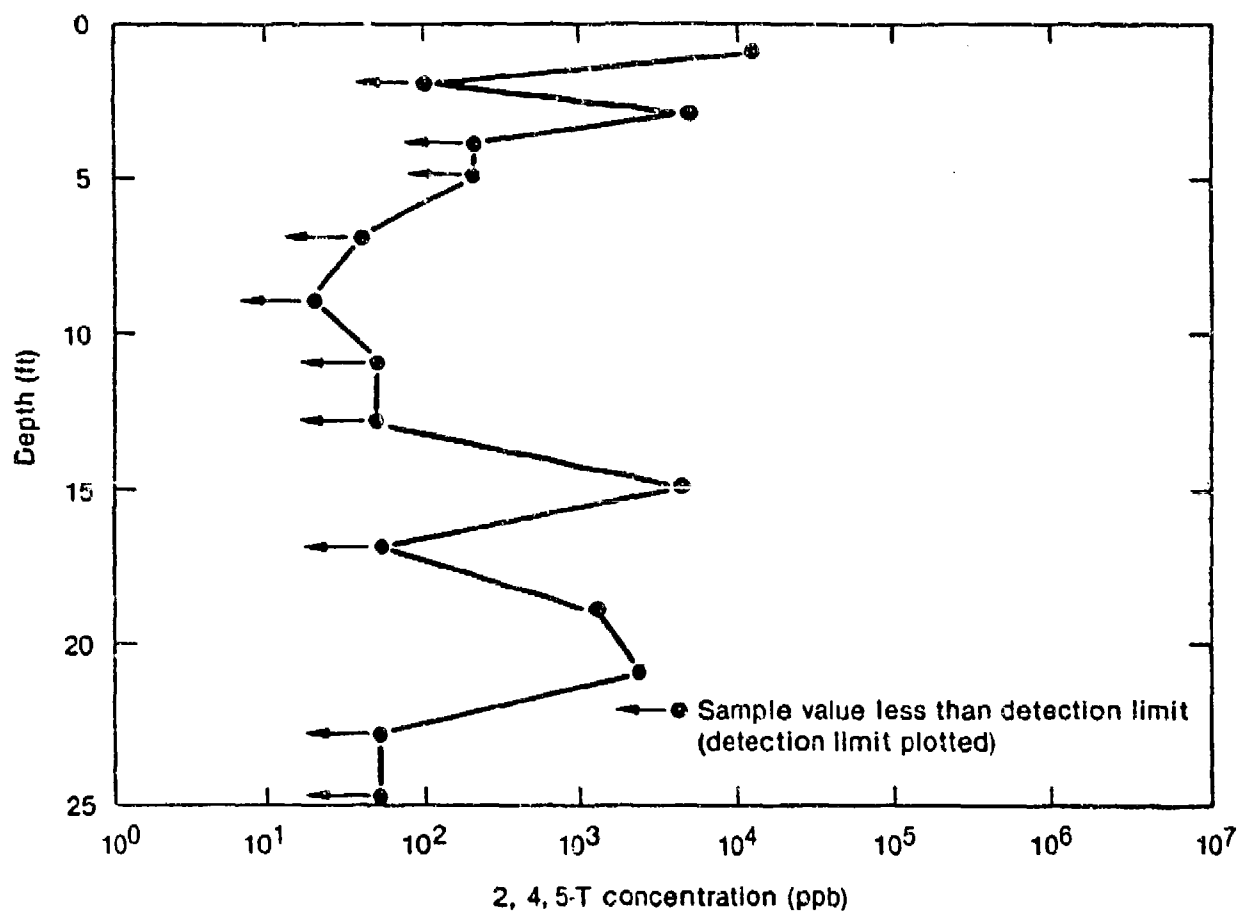
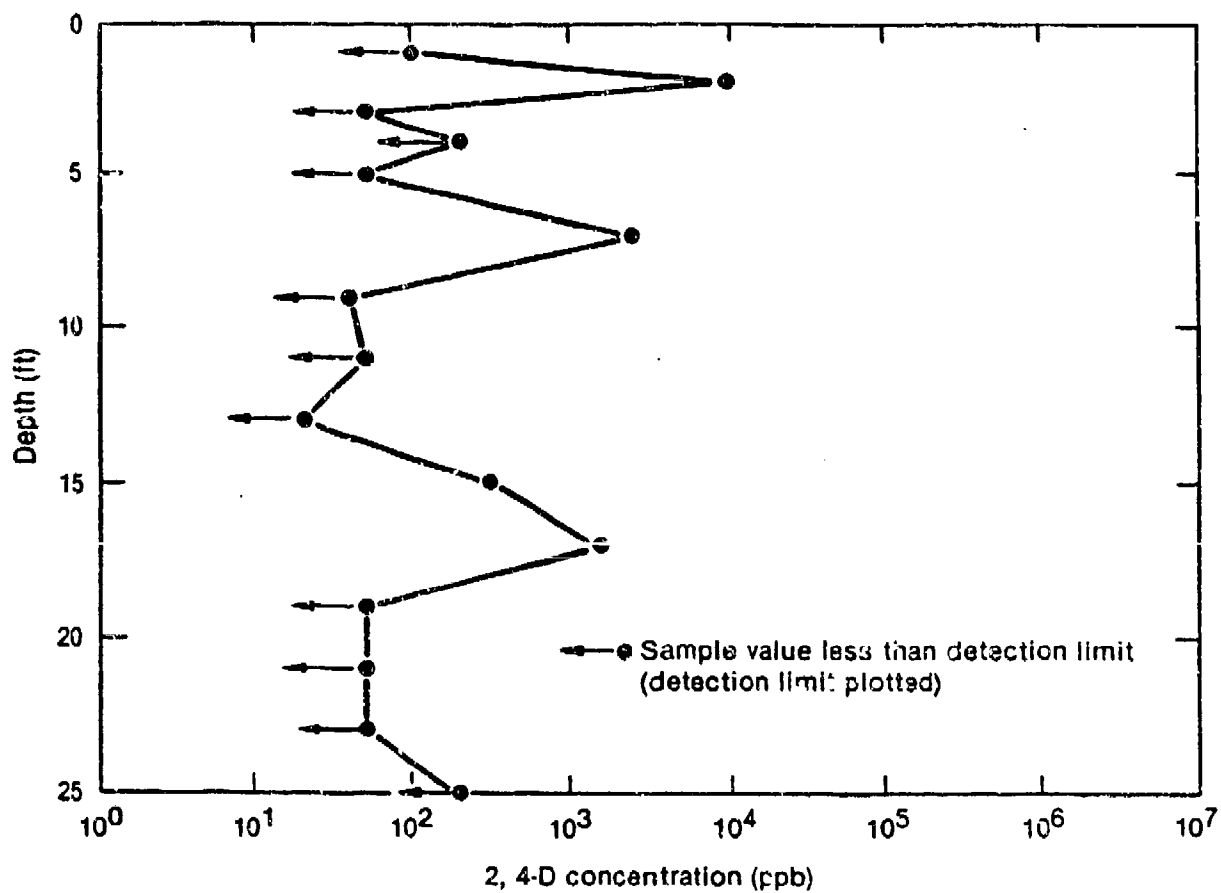
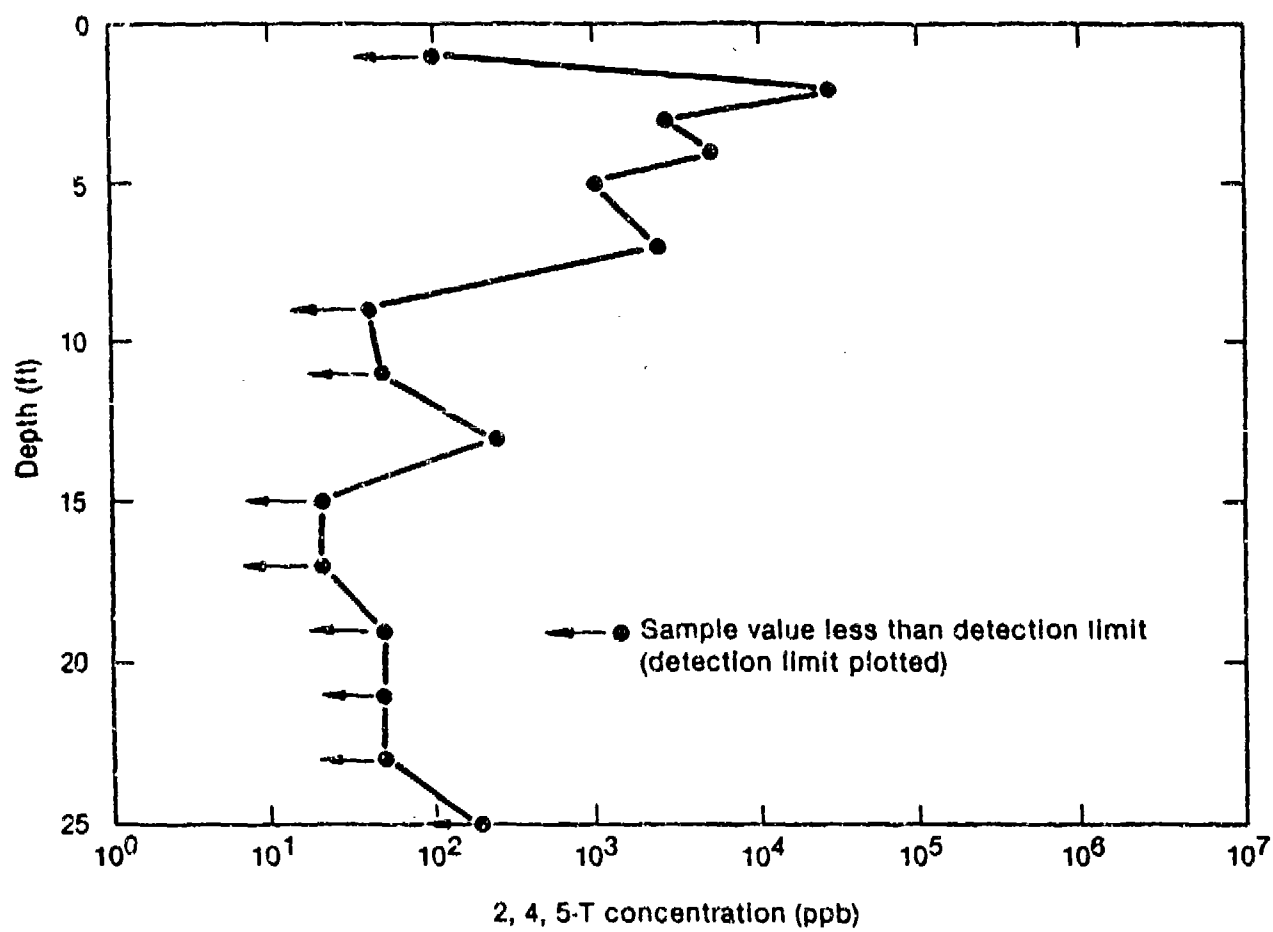
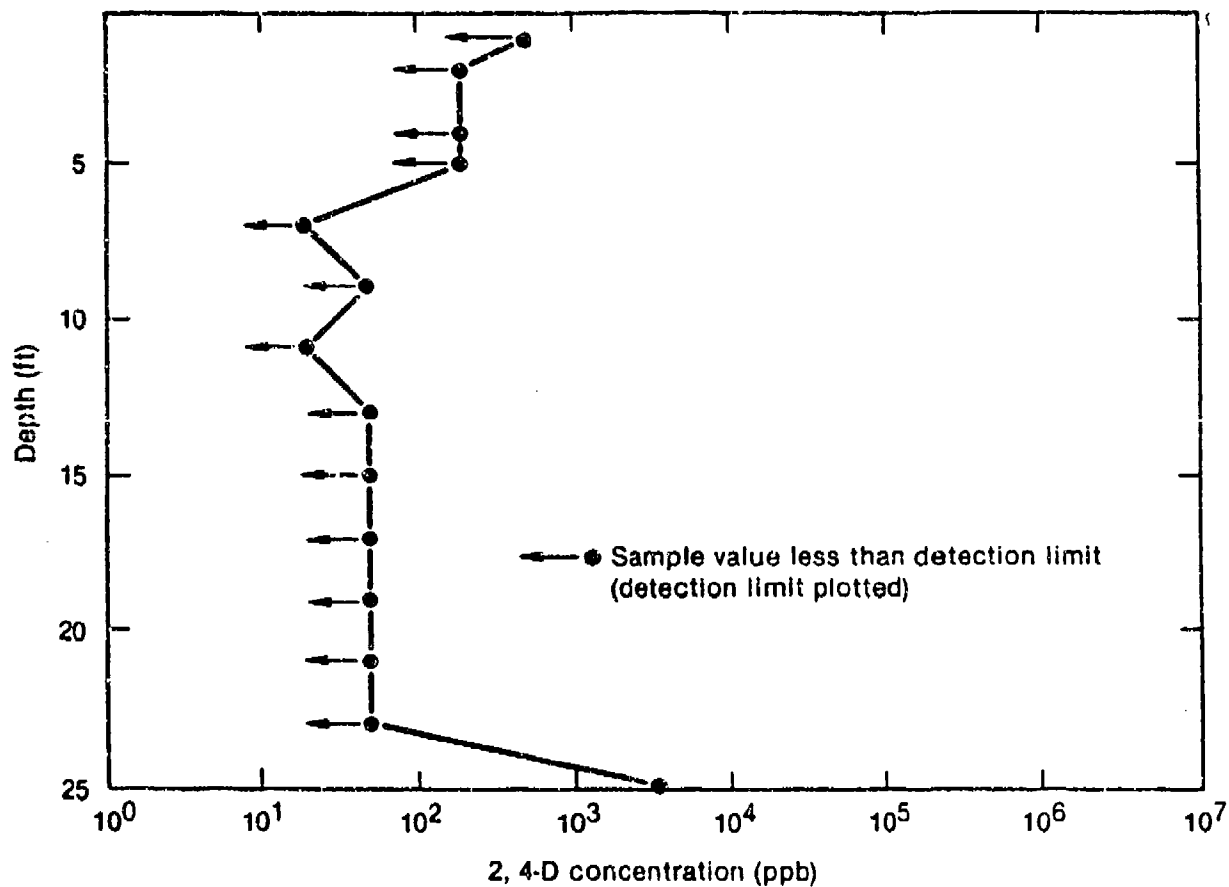
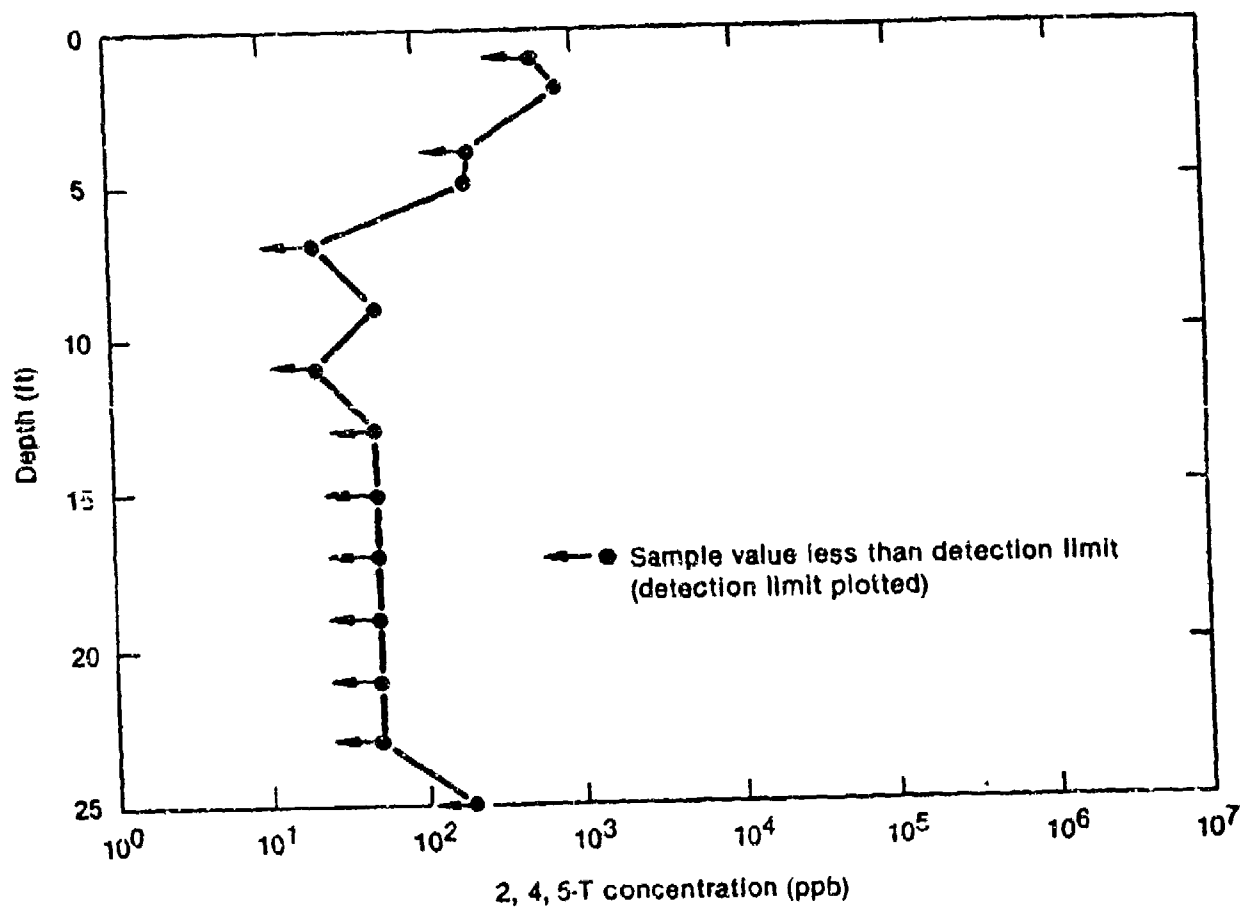
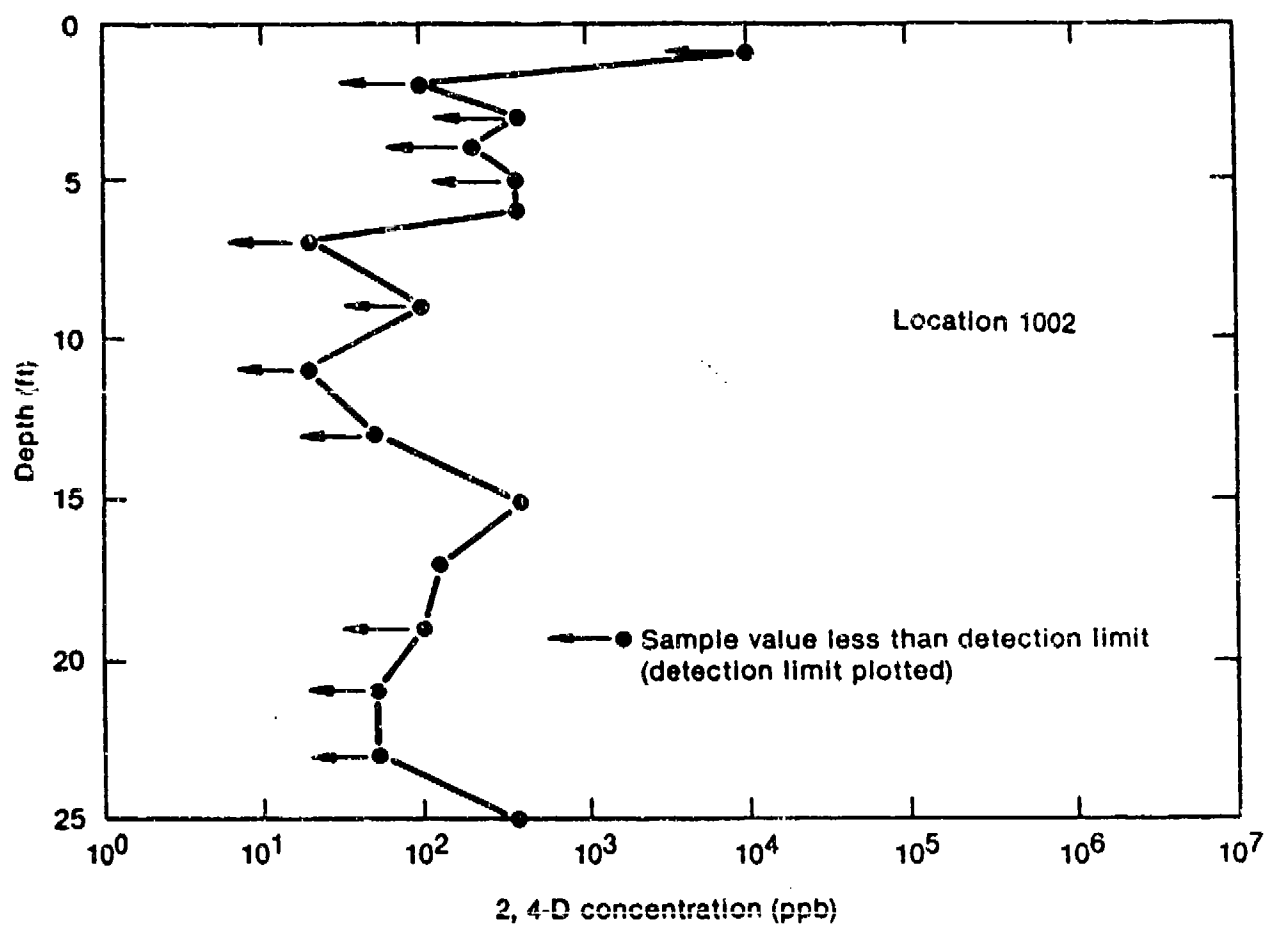
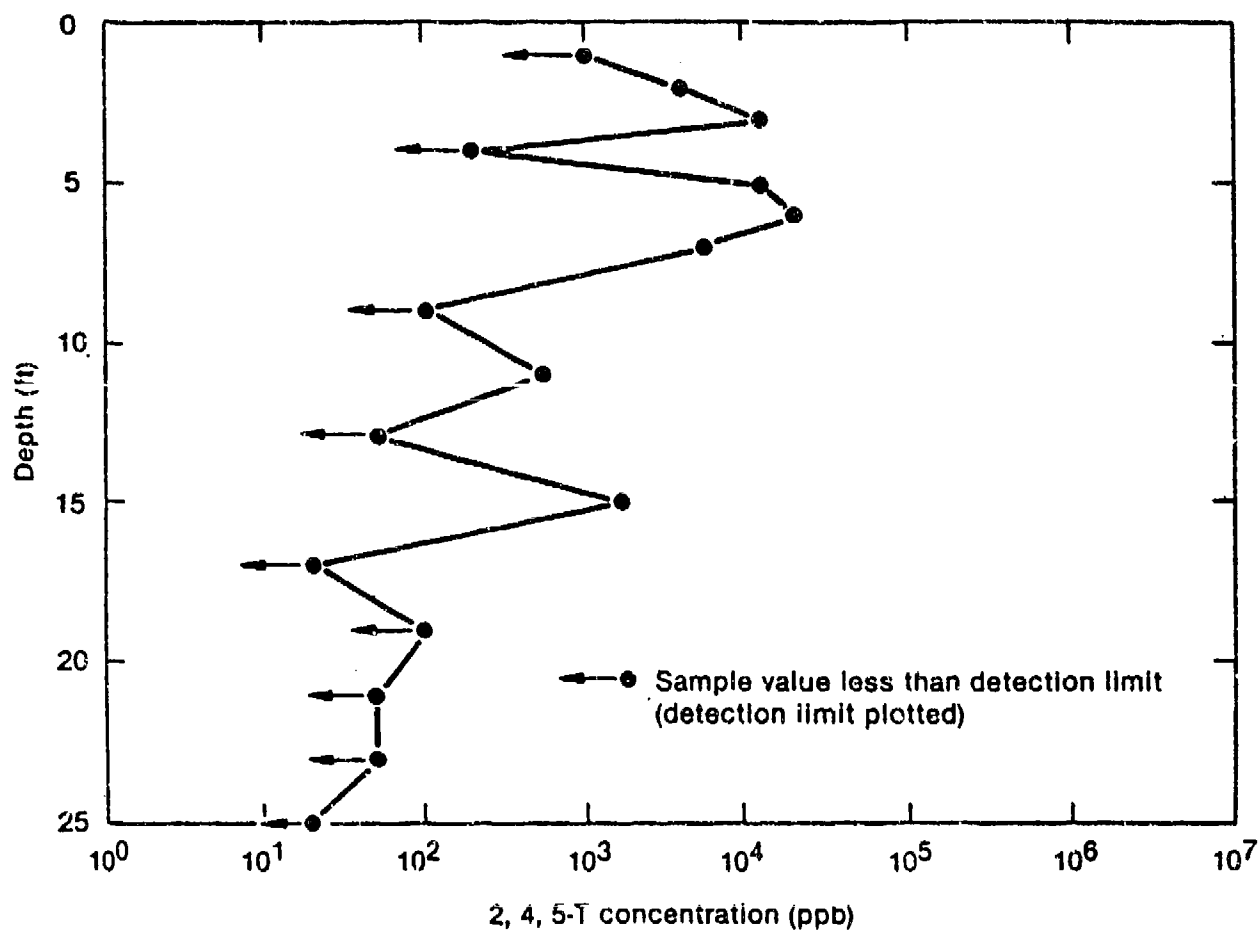
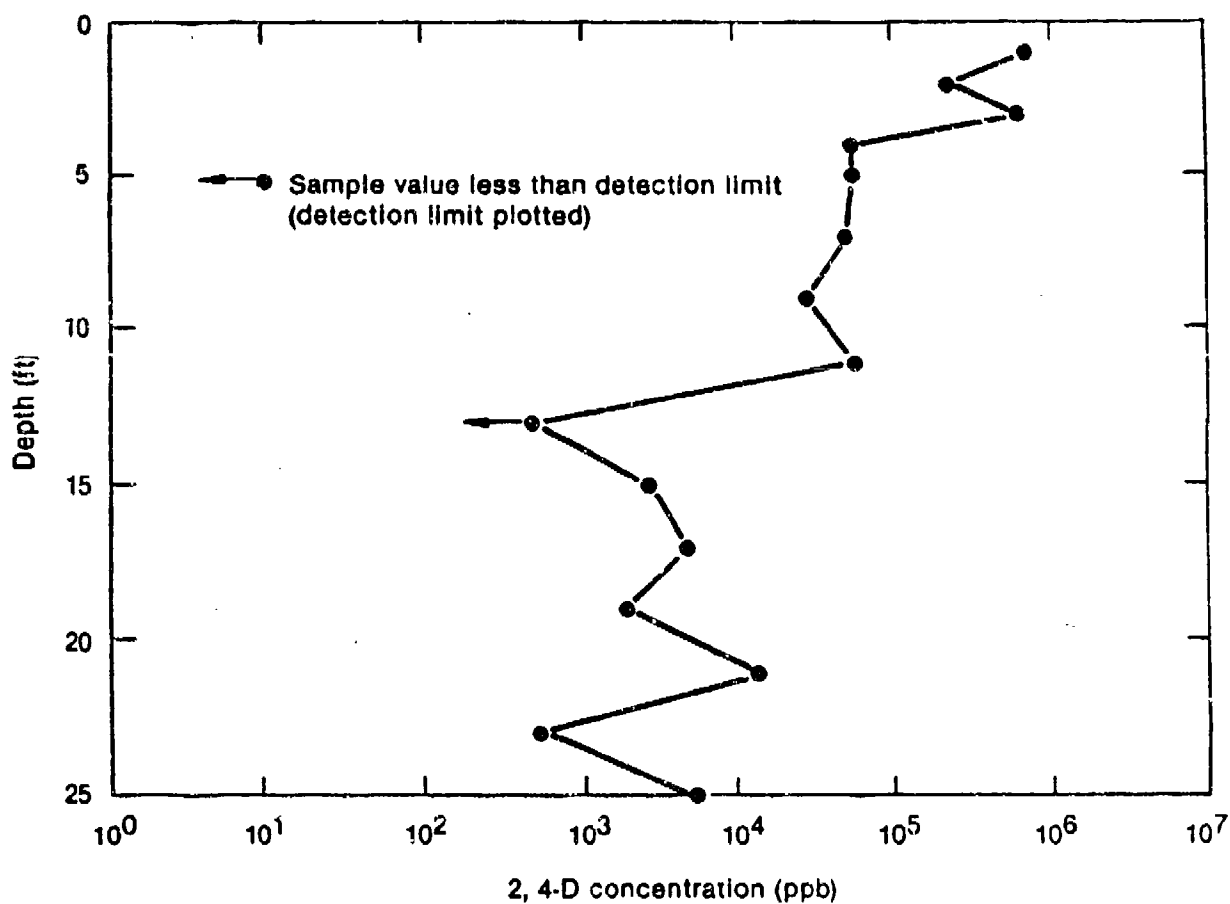
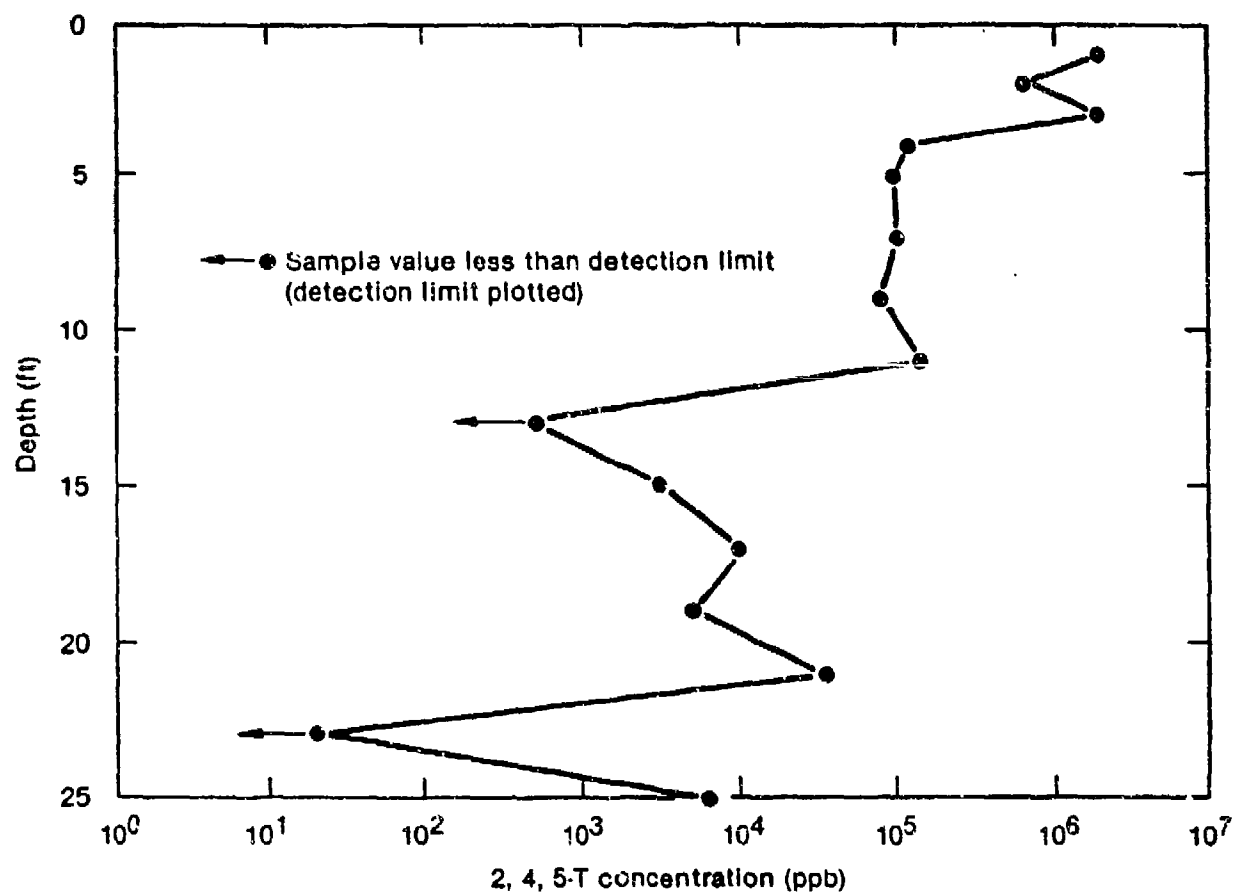
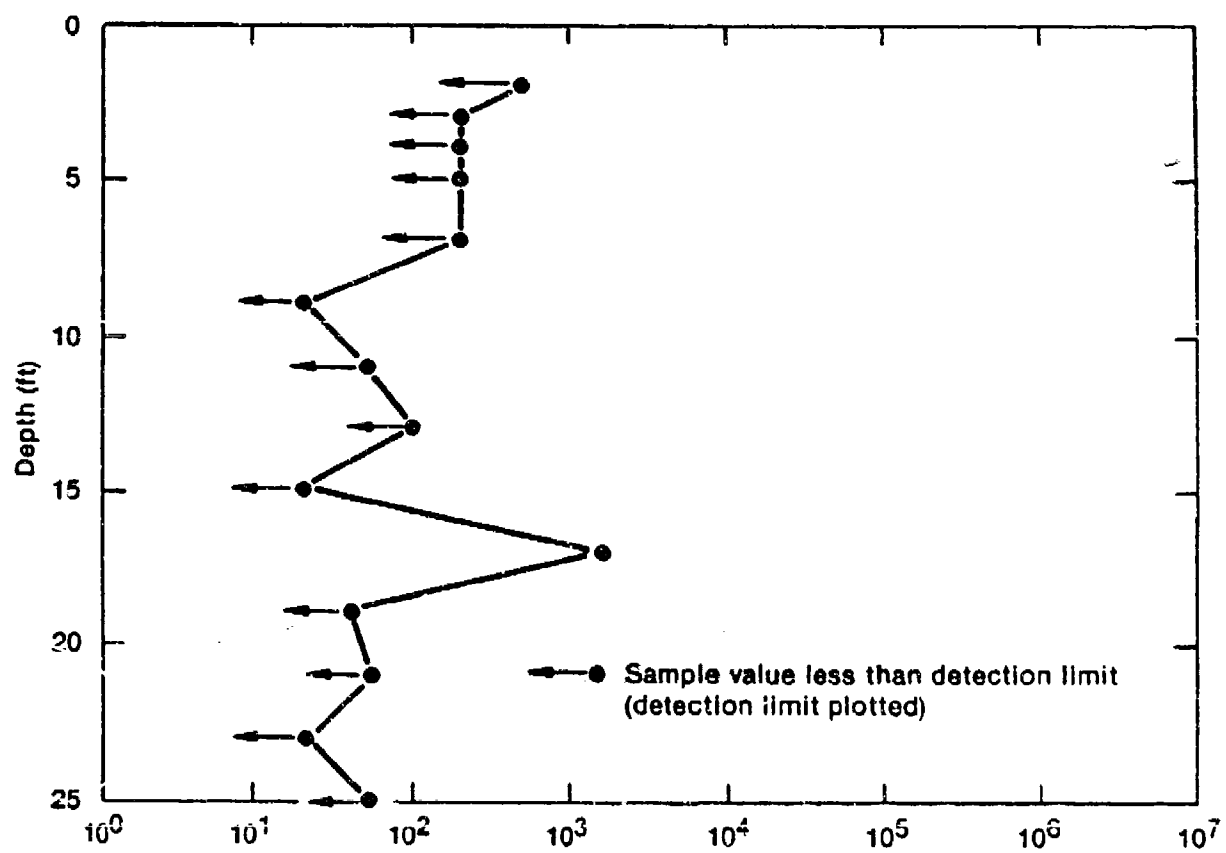
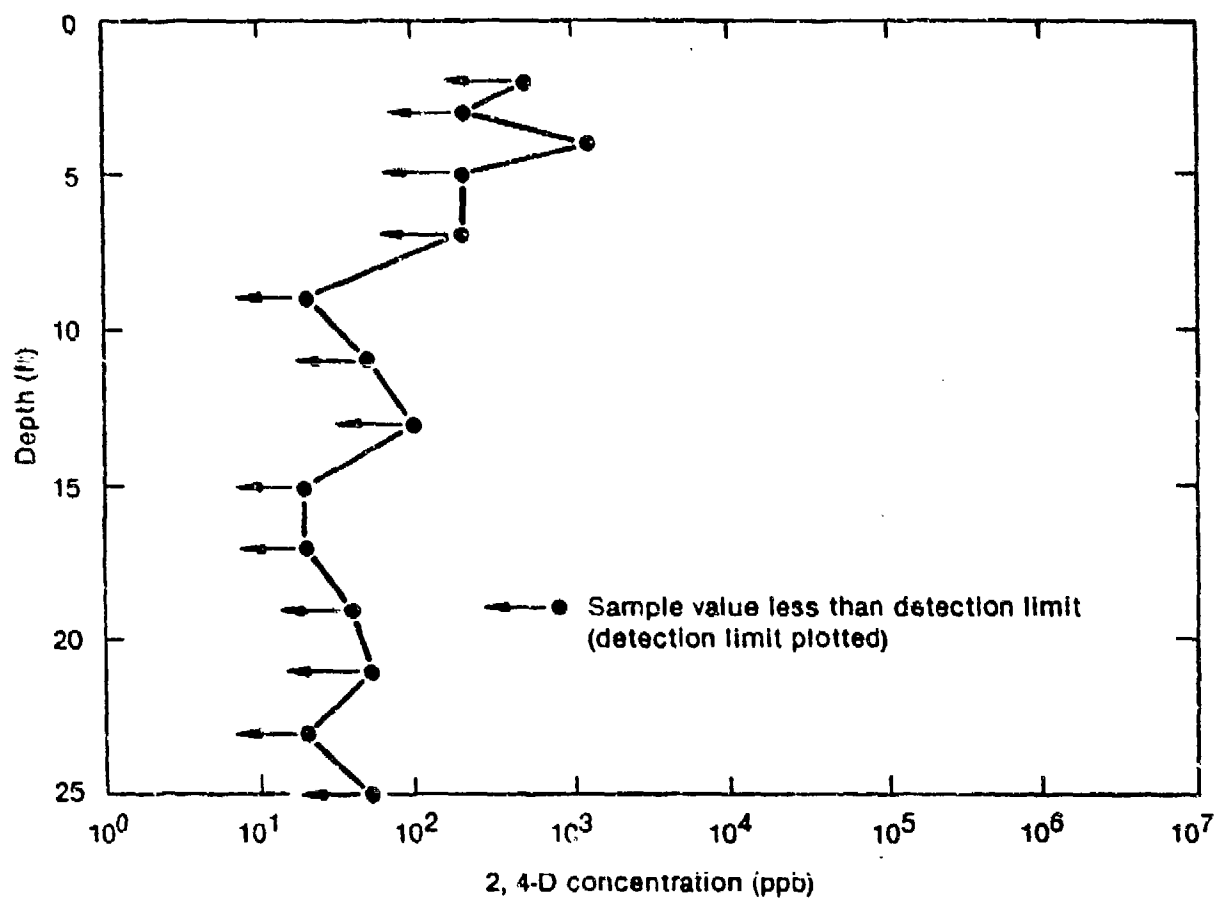
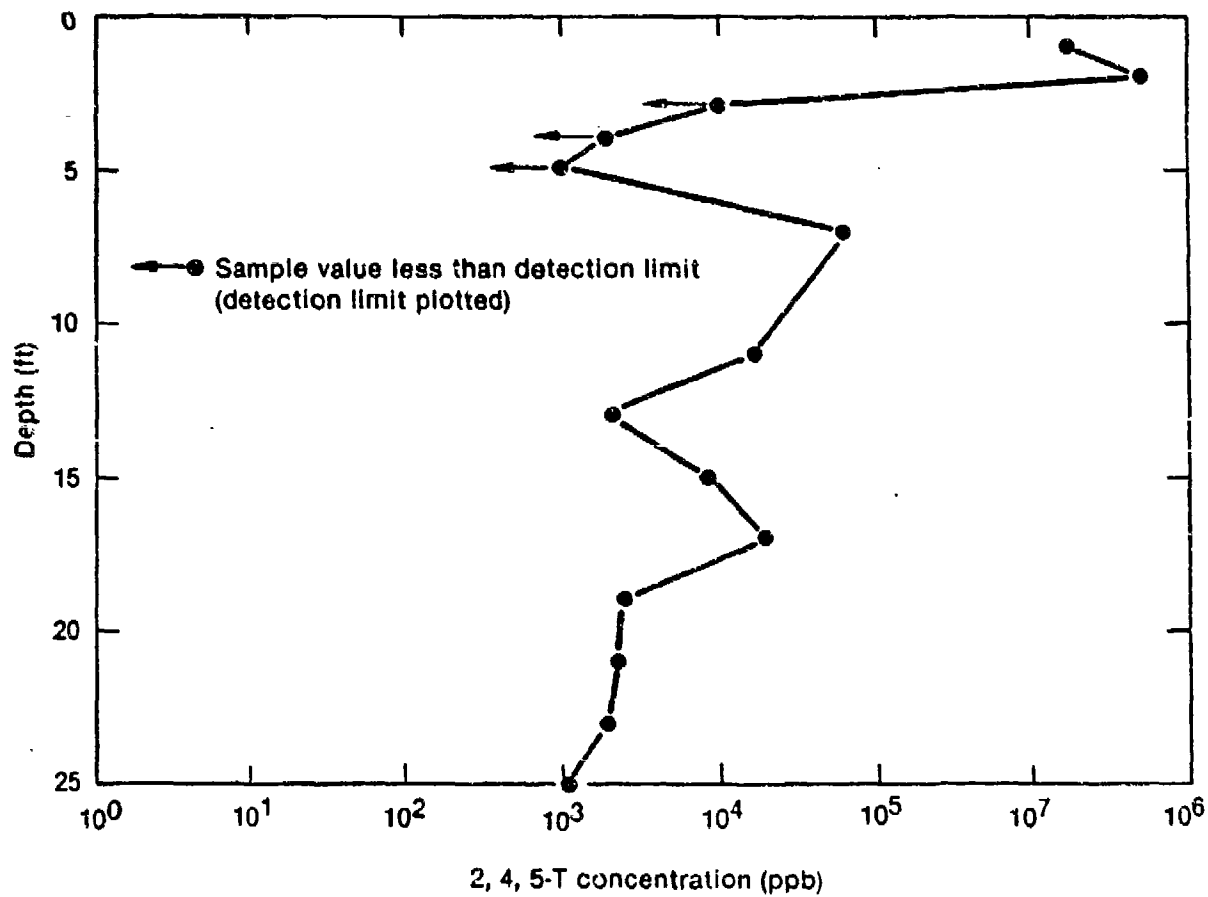
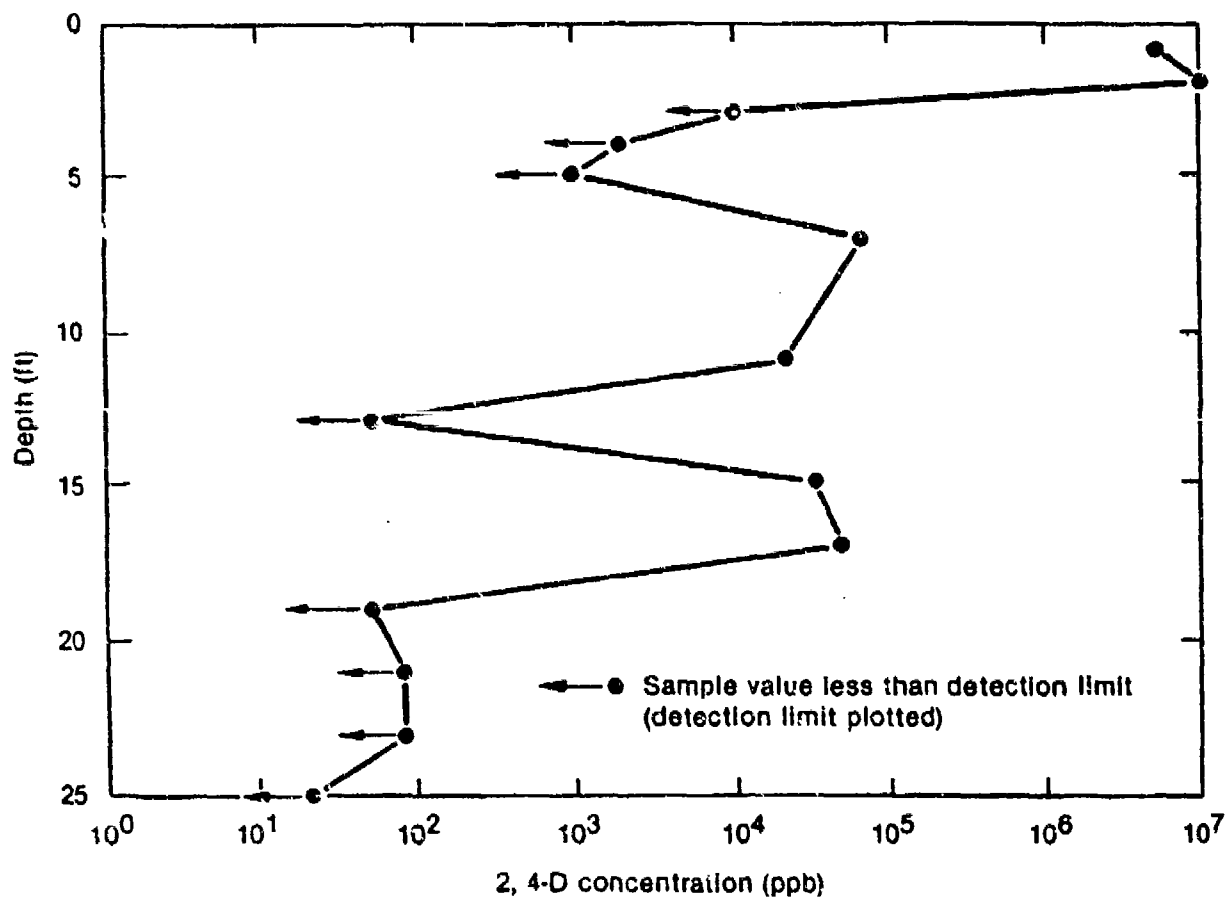
All subsurface samples were analyzed for Herbicide Orange components 2,4-D and 2,4,5-T. The results are presented in Appendix A. Depth profiles for each location are given in Figures 31 through 44. The herbicide analytical results were examined, and statistical correlation between 2,4-D/2,4,5-T, 2,4-D/TCDD, and 2,4,5-T/TCDD were calculated at each depth. The analytical results were transformed using natural logarithms, and less-than-detectable results were replaced by the reporting limit.
